# Safety Inspection Report

Annual Inspection

Broad Town Parish Council

Site name: **Play Area**  
Date of inspection: **04 October 2023**  
Inspector: **Jonathan Peters**

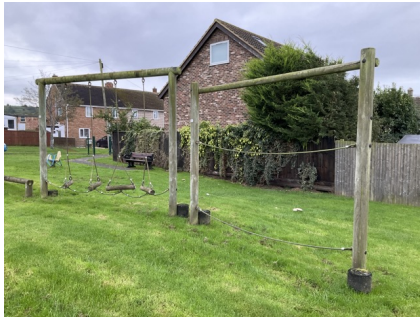
This equipment relies on one post for its stability. Special attention should be paid to maintenance (e.g. by monitoring degradation) and if necessary decommissioning the item before the end of its operating life.

Medium

8

The ID label indicates the equipment was installed in 2003. Routinely check for decay.

Read the notes for further action.

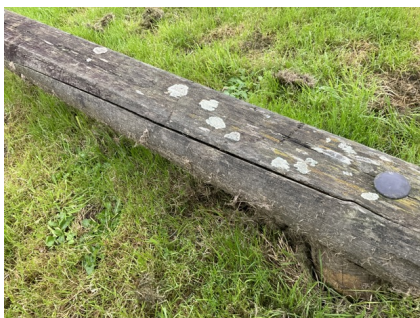
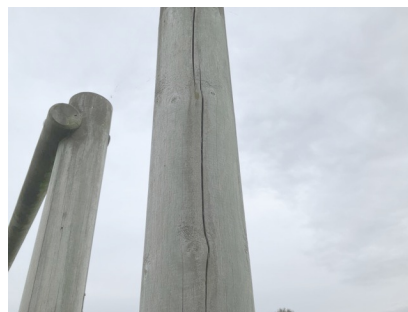
There are natural splits / shakes in the timbers.

Low

4

Shakes vary. Monitor and consult manufacturer if dimensions exceed 8 mm at sections used to grip / grasp.

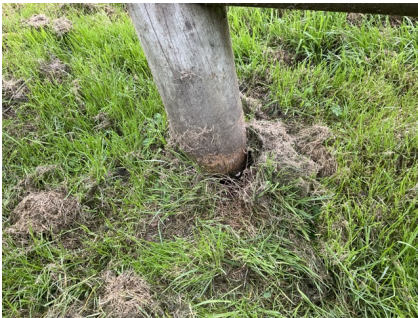
Strimmer damage is present on posts, allowing water to enter and timbers to soften. It can also remove the protective envelope around the timber. Prevent further damage and check timbers for decay throughout the year.

Low

4

Prevent further damage.

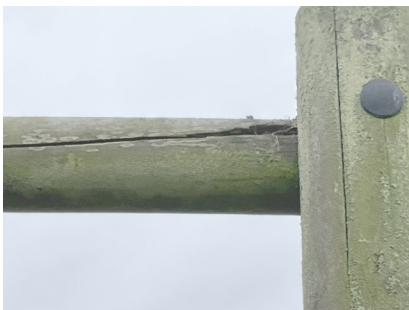
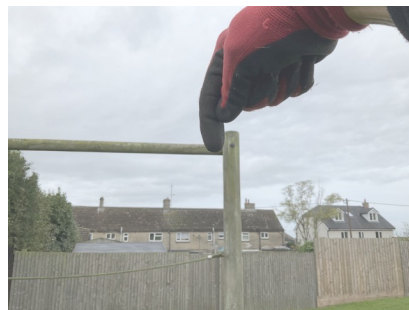
Timber is decayed.

Top bar of rope walk.

Medium

8

Replace affected parts.

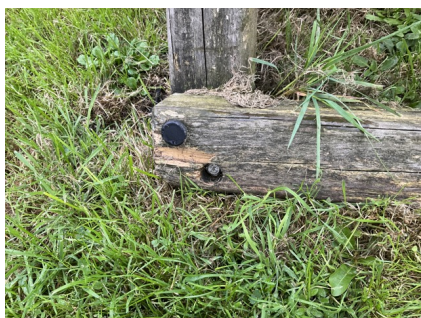
Cap missing.

Very low

1

Replace.

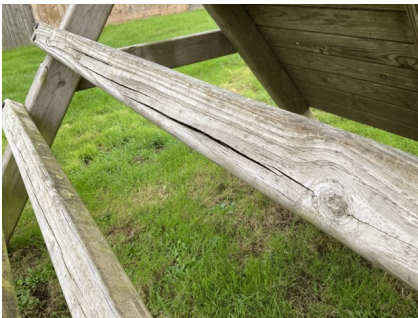
There are natural splits / shakes in the timbers.

■ Low

■ 4

Shakes vary. Monitor and consult manufacturer if dimensions exceed 8 mm at sections used to grip / grasp.

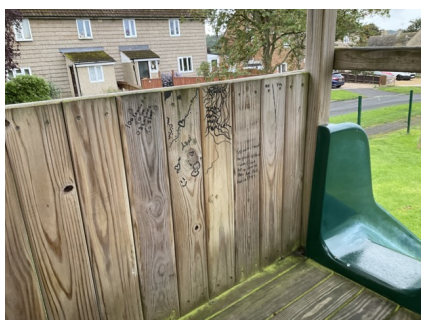
There is graffiti on the unit.

**Very low**

**0**

Remove.

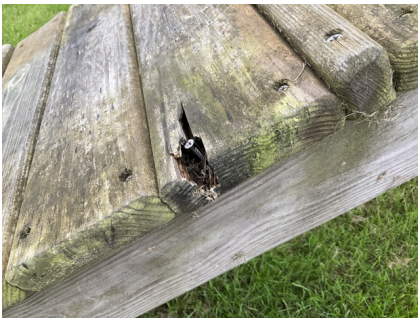
Timber is decayed.

Low

6

Replace affected parts.

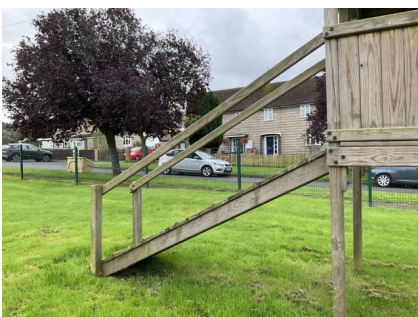
The equipment is easily accessible, has a free height of fall exceeding 600 mm, but does not have barriers to the standing surface.

Low

5

Monitor.

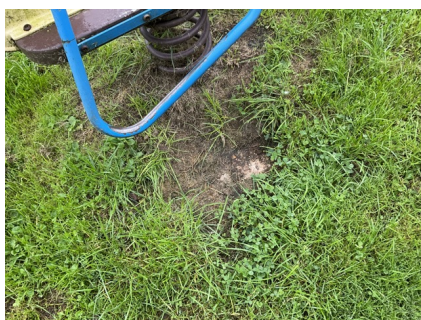
Worn ground areas.

Concrete exposed.

**Risk level:**  
Low

**Risk score:**  
4

Make good.

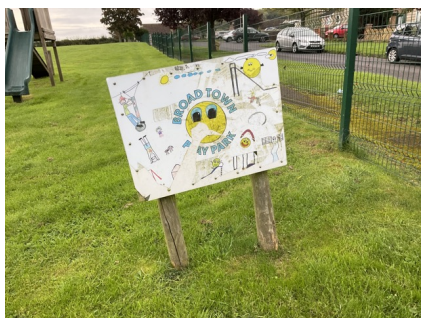
Loose in ground.

Low

4

Reset.

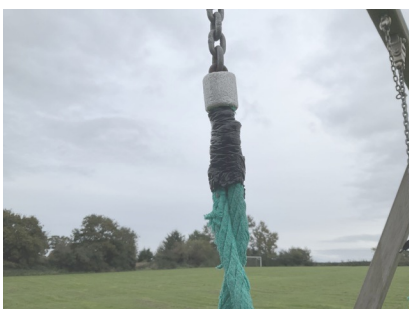
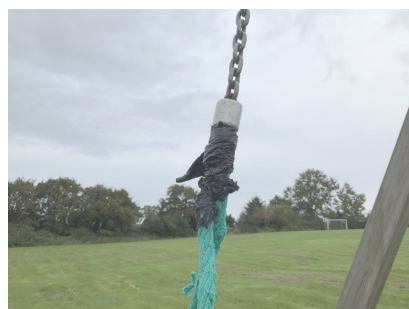
Item is damaged.

Ropes are being twisted and damaged. Continue to monitor the repair which has been undertaken.

Very low

3

Read the notes for further action.

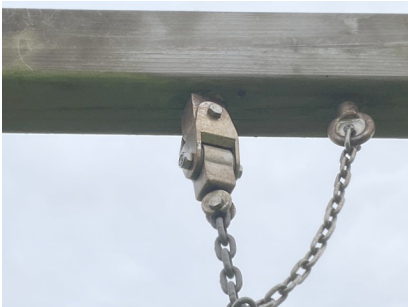
Incorrectly installed.

Low

4

Align swing hanger in correct orientation to the top bar.

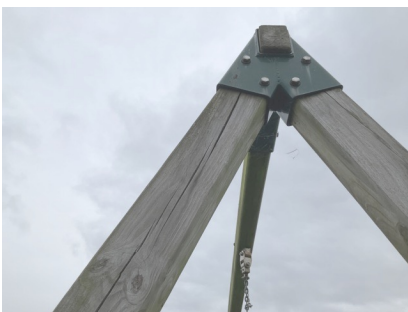
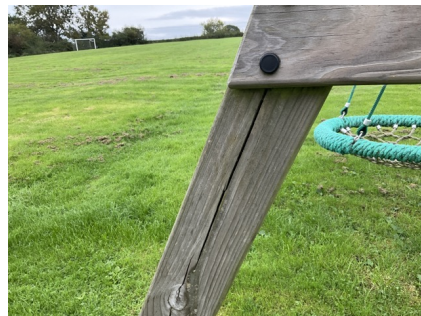
There are natural splits / shakes in the timbers.

Low

4

Shakes vary. Monitor and consult manufacturer if dimensions exceed 8 mm at sections used to grip / grasp.

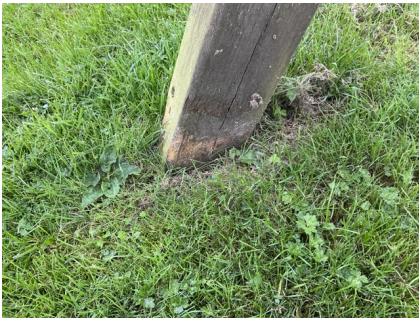
Strimmer damage is present on posts, allowing water to enter and timbers to soften. It can also remove the protective envelope around the timber. Prevent further damage and check timbers for decay throughout the year.

Very low

3

Prevent further damage.

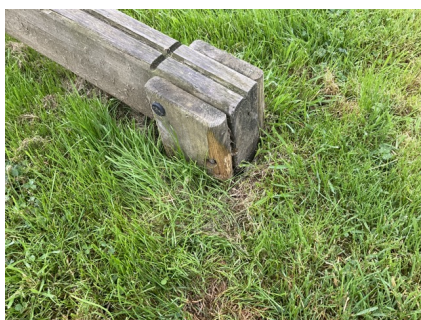
Strimmer damage is present on posts, allowing water to enter and timbers to soften. It can also remove the protective envelope around the timber. Prevent further damage and check timbers for decay throughout the year.

**Very low**

**3**

Prevent further damage.

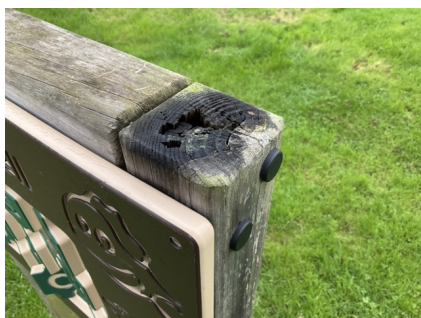
Timber is decayed.

**Risk level:**  
Very low

**Risk score:**  
3

Check on a routine basis.
