Safety Inspection Report

Annual Inspection

Play Area

Broad Town Parish Council

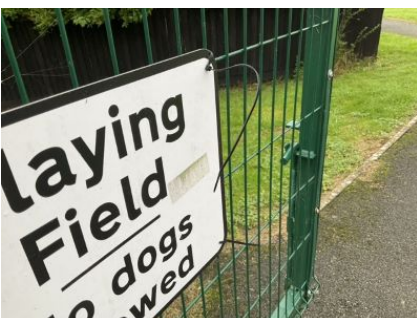
Signage - Dog Ban

Additional comments are noted below.

Trim cable ties.

Read the notes for further action.

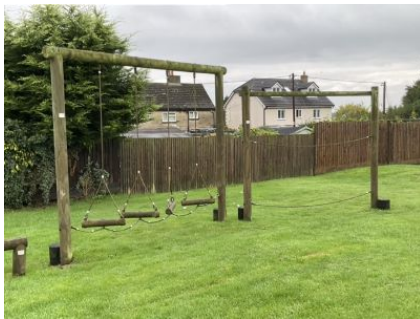
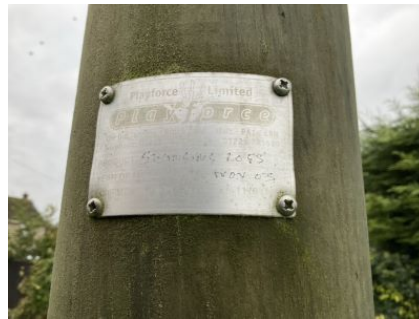
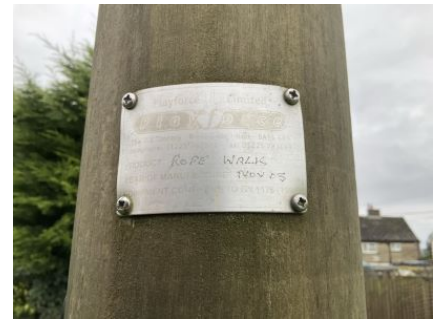
Agility - Balance Trail

This equipment relies on one post for its stability. Special attention should be paid to maintenance (e.g. by monitoring degradation) and if necessary decommissioning the item before the end of its operating life.

The ID label indicates the equipment was installed in 2003. Routinely check for decay.

Read the notes for further action.

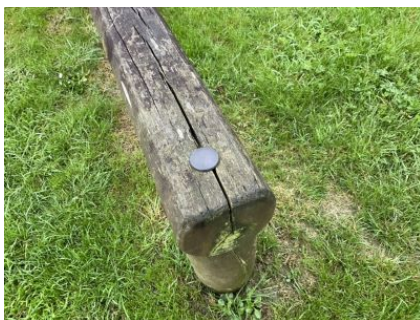
There are natural splits / shakes in the timbers.

Shakes vary. Monitor and consult manufacturer if dimensions exceed 8 mm at sections used to grip / grasp.

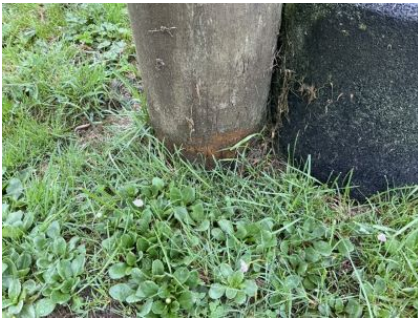
Strimmer damage is present on posts, allowing water to enter and timbers to soften. It can also remove the protective envelope around the timber. Prevent further damage and check timbers for decay throughout the year.

Prevent further damage.

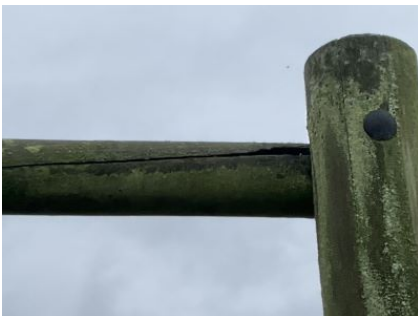
Timber is decayed.

Top bar of rope walk.

Replace affected parts.

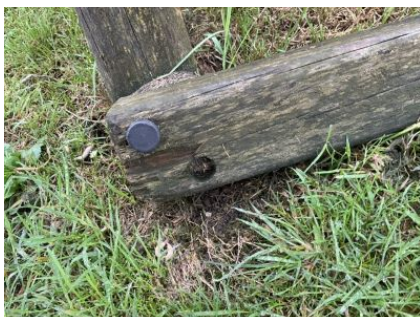
Climber - Up & Over

Cap missing.

Replace.

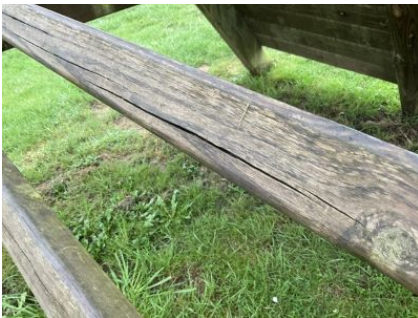
There are natural splits / shakes in the timbers.

Shakes vary. Monitor and consult manufacturer if dimensions exceed 8 mm at sections used to grip / grasp.

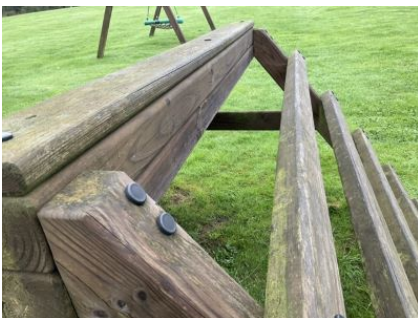
There is a head entrapment.

Refer to manufacturer for comment.

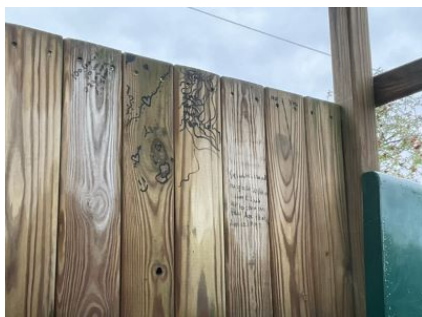
Multiplay

There is graffiti on the unit.

Remove.

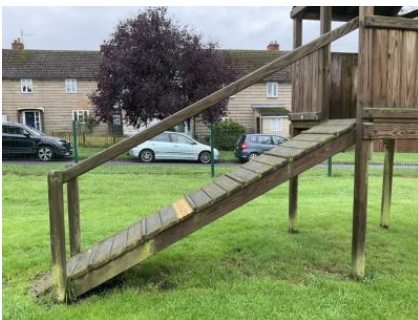
The equipment is easily accessible, has a free height of fall exceeding 600 mm, but does not have barriers to the standing surface.

Monitor.

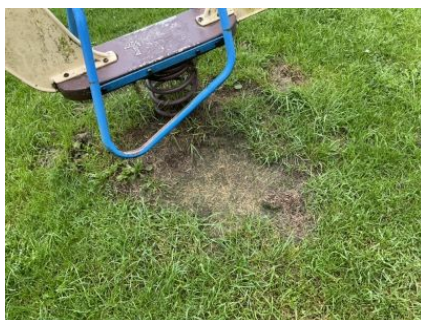
Rocker - Bird

Worn ground areas.

Concrete exposed.

Make good.

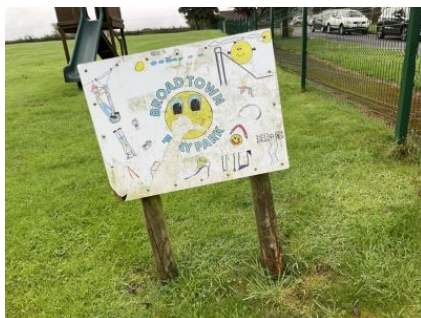
Play Panel

Loose in ground.

Reset.

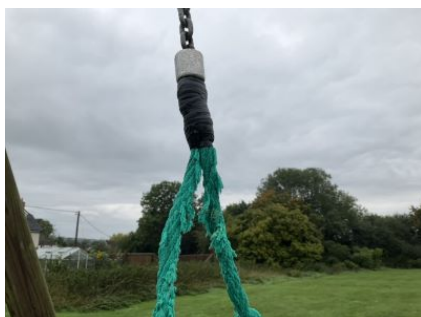
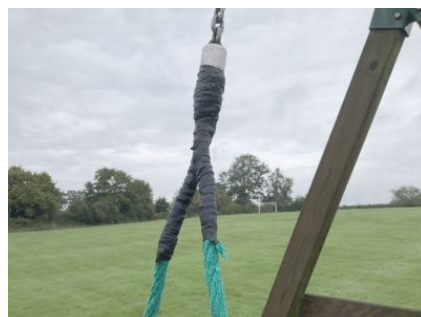
Swing - Basket

Item is damaged.

Ropes are being twisted and damaged. Continue to monitor the repair which has been undertaken.

Read the notes for further action.

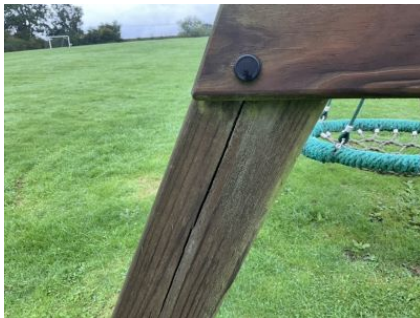
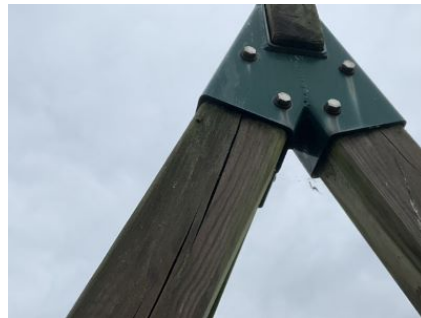
There are natural splits / shakes in the timbers.

Shakes vary. Monitor and consult manufacturer if dimensions exceed 8 mm at sections used to grip / grasp.

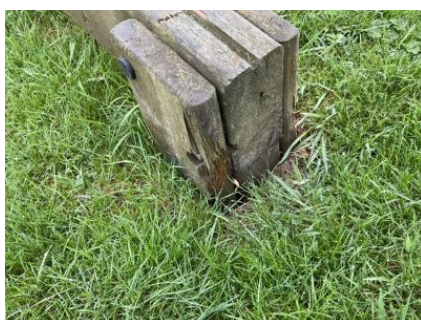
Balance Beam

Strimmer damage is present on posts, allowing water to enter and timbers to soften. It can also remove the protective envelope around the timber. Prevent further damage and check timbers for decay throughout the year.

Prevent further damage.

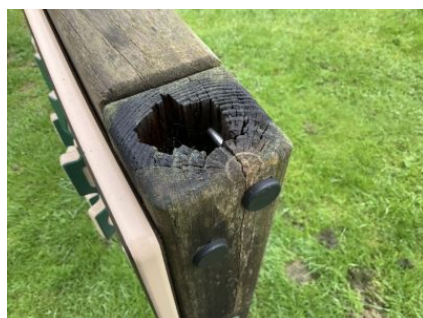
Play Panel - Animal Spell

Timber is decayed.

Check on a routine basis.
