# Safety Inspection Report

Annual Inspection

Broad Town Parish Council

12 September 2025

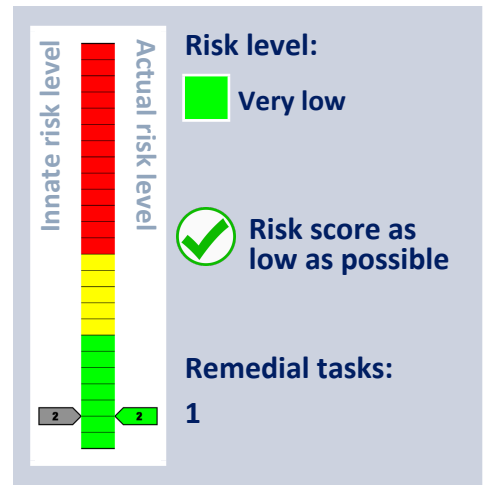
| Description |
|---|
| Additional comments are noted below. |
| Trim cable ties. |

| Description |
|---|
| Read the notes for further action. |

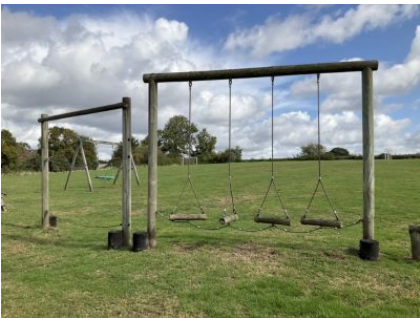
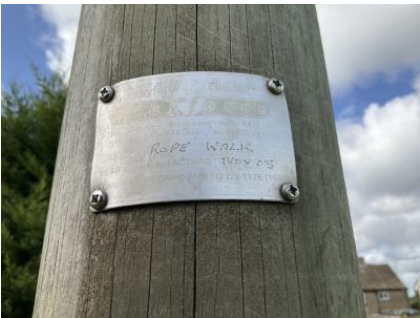
This equipment relies on one post for its stability. Special attention should be paid to maintenance (e.g. by monitoring degradation) and if necessary decommissioning the item before the end of its operating life. This is a requirement of the British Standard.

The ID label indicates the equipment was installed in 2003. Routinely check for decay.

Read the notes for further action.

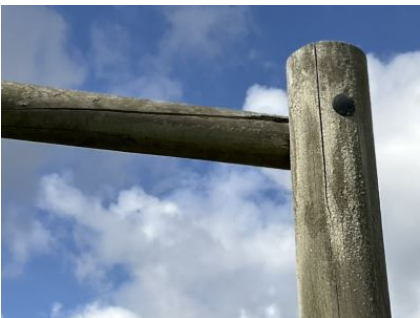
Timber is decayed.

Top bar of rope walk.

Replace affected parts.

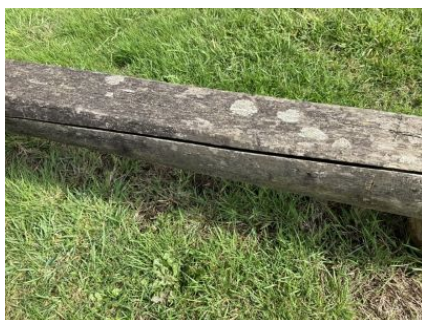
There are natural splits / shakes in the timbers.

Shakes vary. Monitor and consult manufacturer if dimensions exceed 8 mm at sections used to grip / grasp.

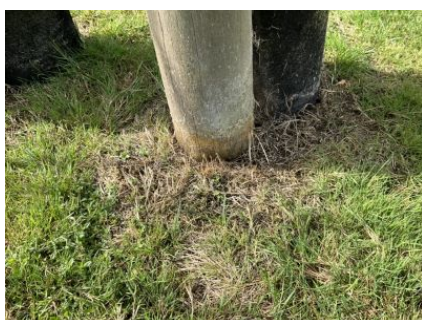
Strimmer damage is present on posts, allowing water to enter and timbers to soften. It can also remove the protective envelope around the timber. Prevent further damage and check timbers for decay throughout the year.

Prevent further damage.

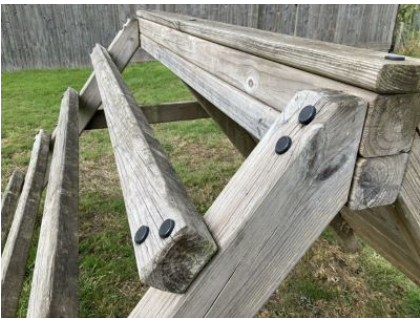
There is a head entrapment.

Refer to manufacturer for comment.

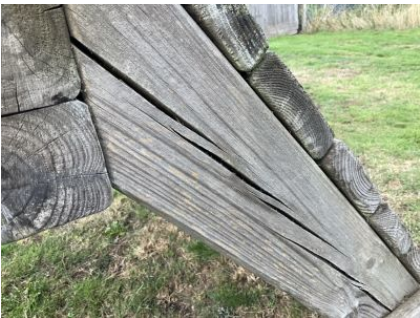
There are natural splits / shakes in the timbers.

Shakes vary. Monitor and consult manufacturer if dimensions exceed 8 mm at sections used to grip / grasp.

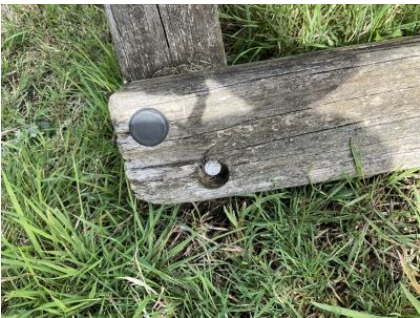
Cap missing.

Replace.

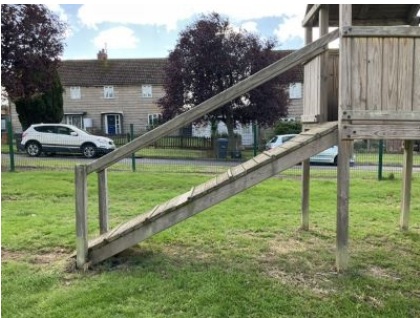
The equipment is easily accessible, has a free height of fall exceeding 600 mm, but does not have barriers to the standing surface.

Read the notes for further action.

Monitor.

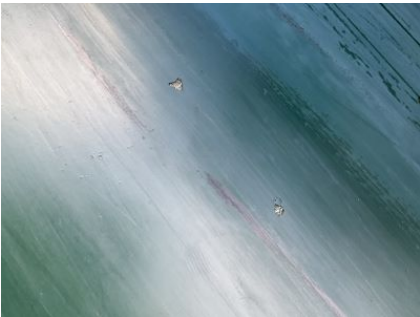
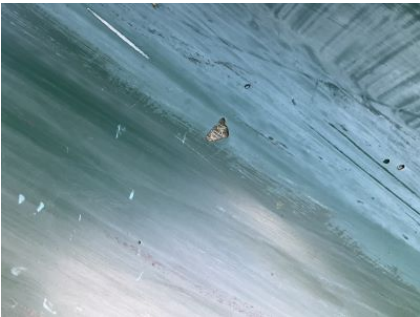
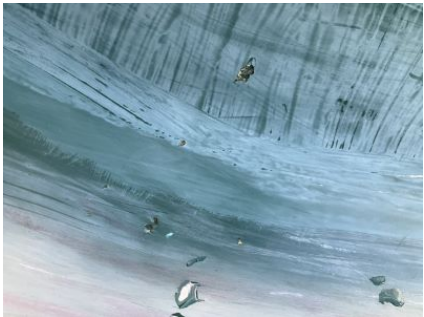
Item is damaged.

Repair.

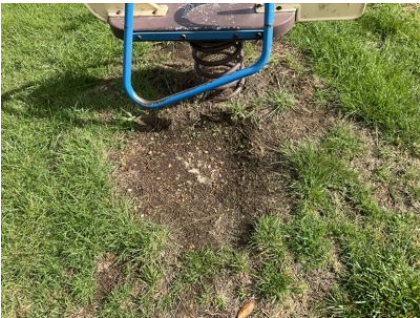
Worn ground areas.

Concrete exposed.

Make good.

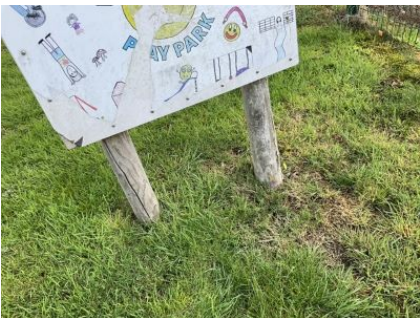
Loose in ground.

Reset.

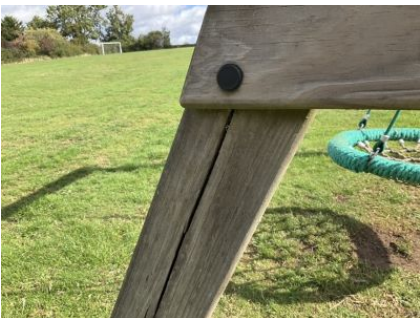
There are natural splits / shakes in the timbers.

Shakes vary. Monitor and consult manufacturer if dimensions exceed 8 mm at sections used to grip / grasp.

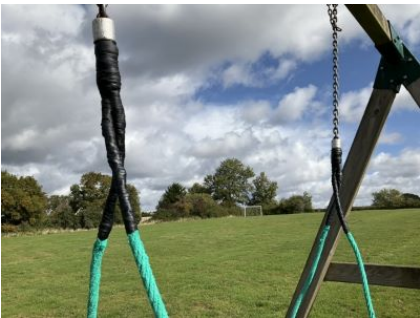
Item is damaged.

Ropes are being twisted and damaged. Continue to monitor the repair which has been undertaken.

Read the notes for further action.

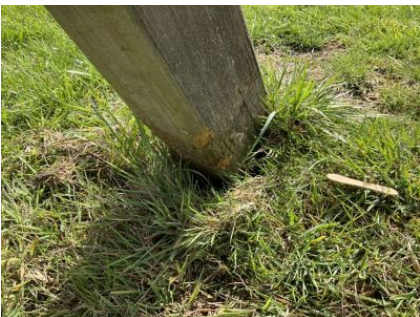
Strimmer damage is present on posts, allowing water to enter and timbers to soften. It can also remove the protective envelope around the timber. Prevent further damage and check timbers for decay throughout the year.

Prevent further damage.

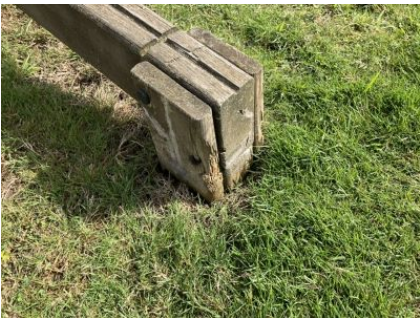
Strimmer damage is present on posts, allowing water to enter and timbers to soften. It can also remove the protective envelope around the timber. Prevent further damage and check timbers for decay throughout the year.

Prevent further damage.

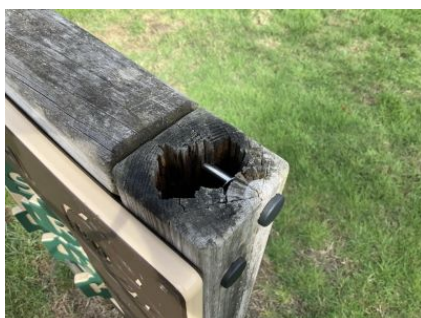
Timber is decayed.

Check on a routine basis.
